Near Miss and Serious Nonfatal Accidents Metal and Nonmetal Mining

September 2013 through December 2014

NEAR MISS AND SERIOUS ACCIDENTS

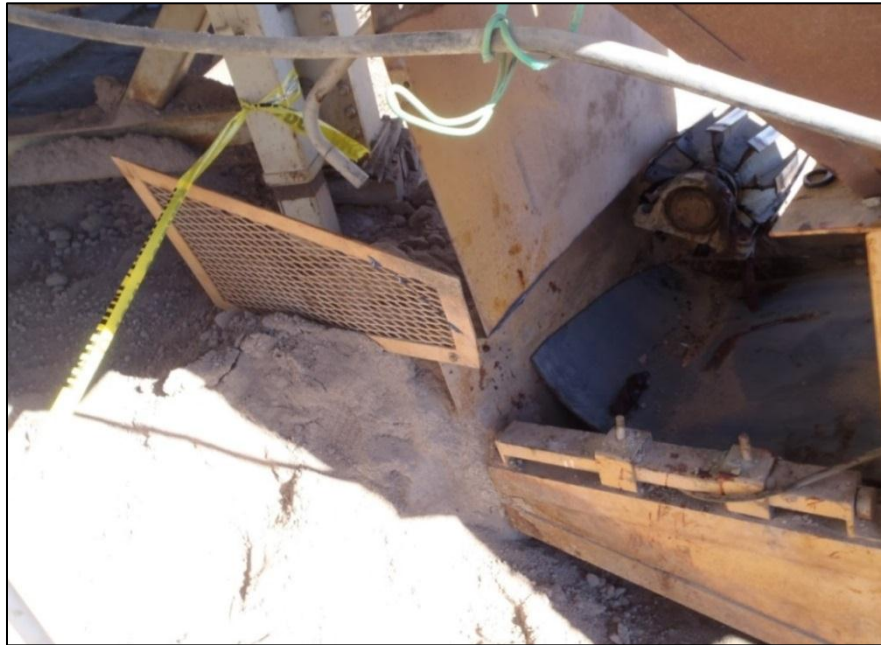
January 27, 2014

A plant foreman removed a guard from the side of an operating self-cleaning belt conveyor tail pulley to clean a buildup of material and became entangled in the rotating pulley. First responders had to perform trauma surgery at the scene to remove the victim's arm from his shoulder to free him from the equipment. The foreman failed to shut off power to the conveyor and did not block the conveyor against hazardous motion before removing the guard.

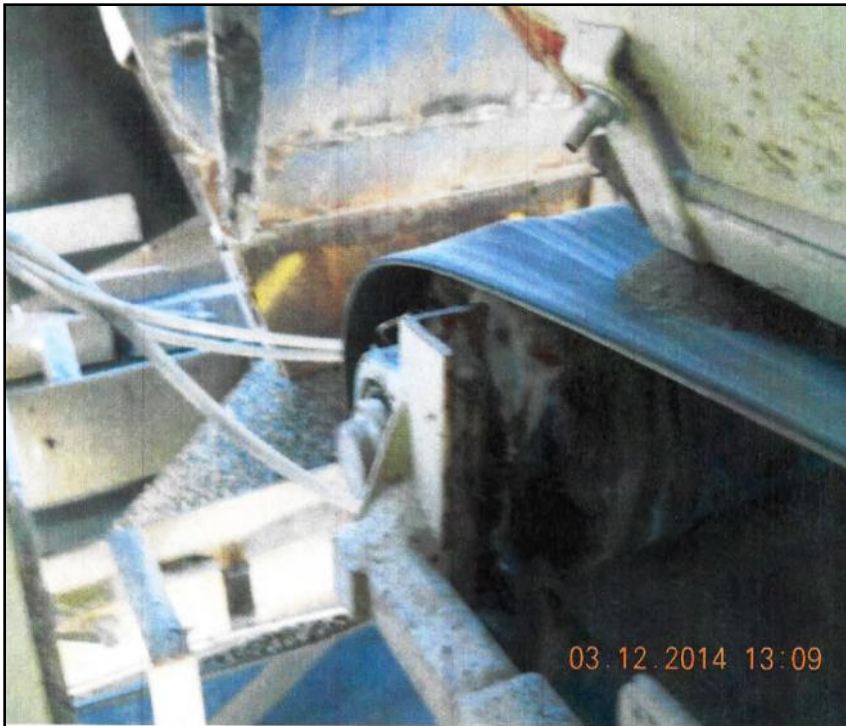
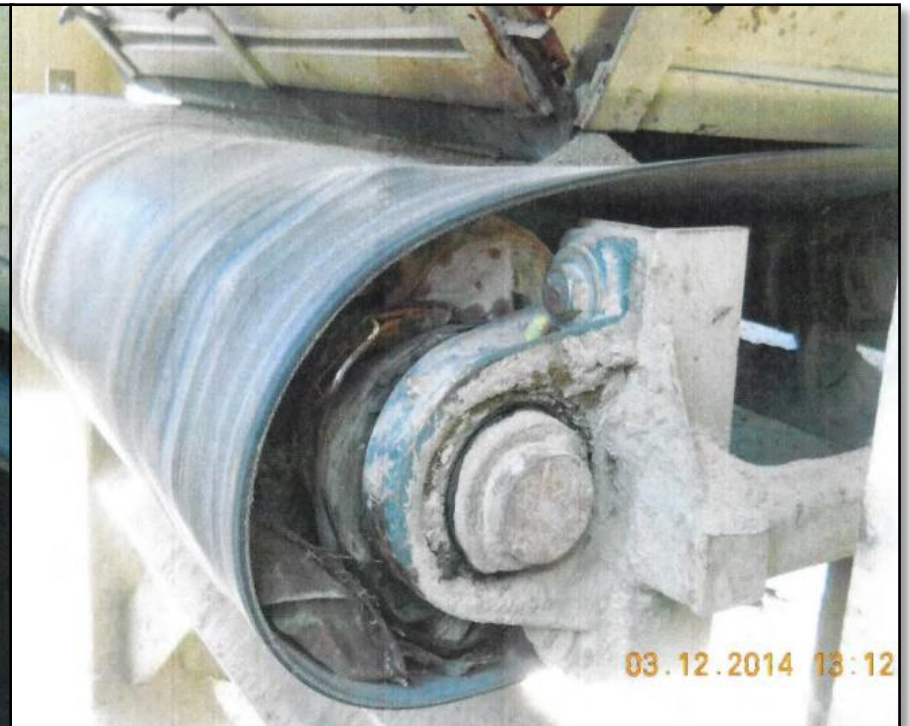
March 12, 2014

Surface Sand & Gravel – The clothing of a miner working near an unguarded rotating belt conveyor tail pulley was drawn into the pulley. The miner suffered serious arm injuries.

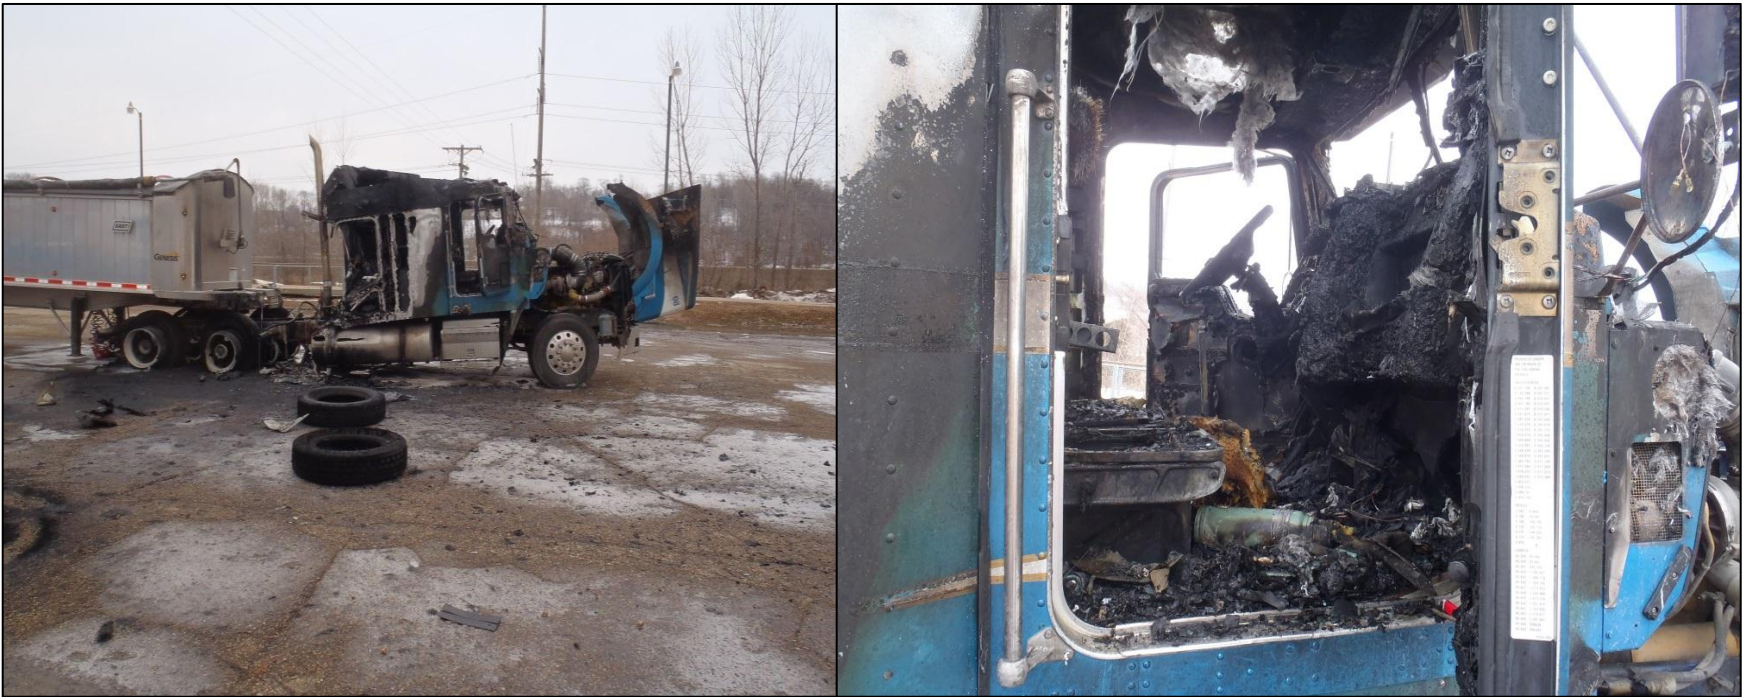
March 18, 2014

Crushed Limestone mine – An over-the-road truck raised the bed and contacted an overhead power line causing the cab and wheels to catch on fire. There were no signs warning of the presence of the overhead power lines, nor did the mine operator provide site specific hazard awareness training to contract truck drivers.

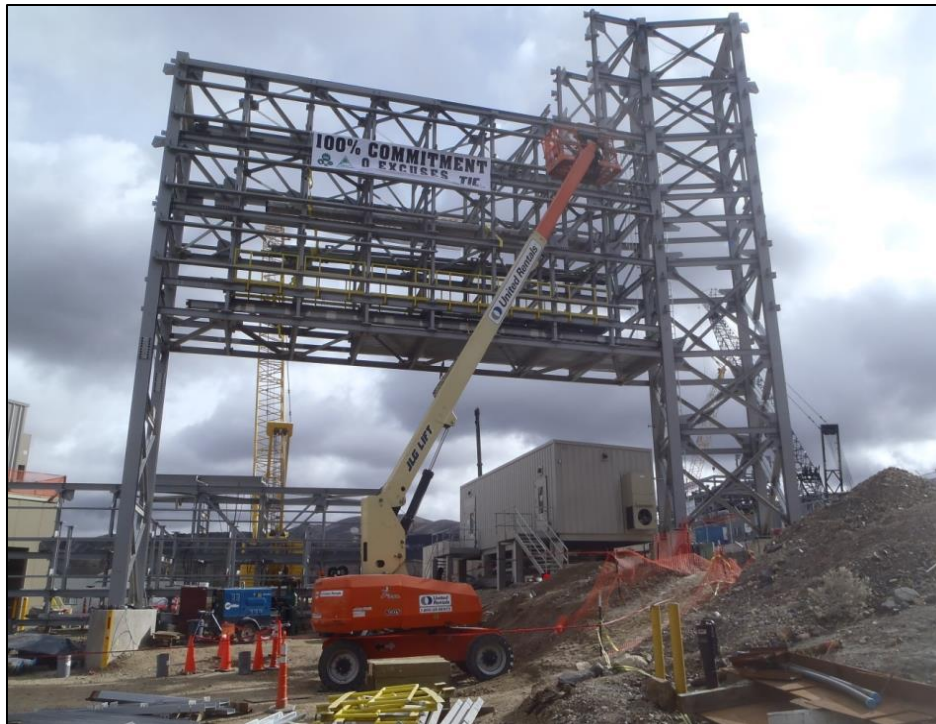
March 25, 2014

Surface Gold Mine Construction Project – Two construction miners were working in an 80-foot manlift when the main extending cable for the upper boom broke. The upper boom retracted uncontrollably into the main boom. The two miners in the basket were wearing the appropriate fall protection, yet they were seriously injured and were transported by EMS to a local hospital.

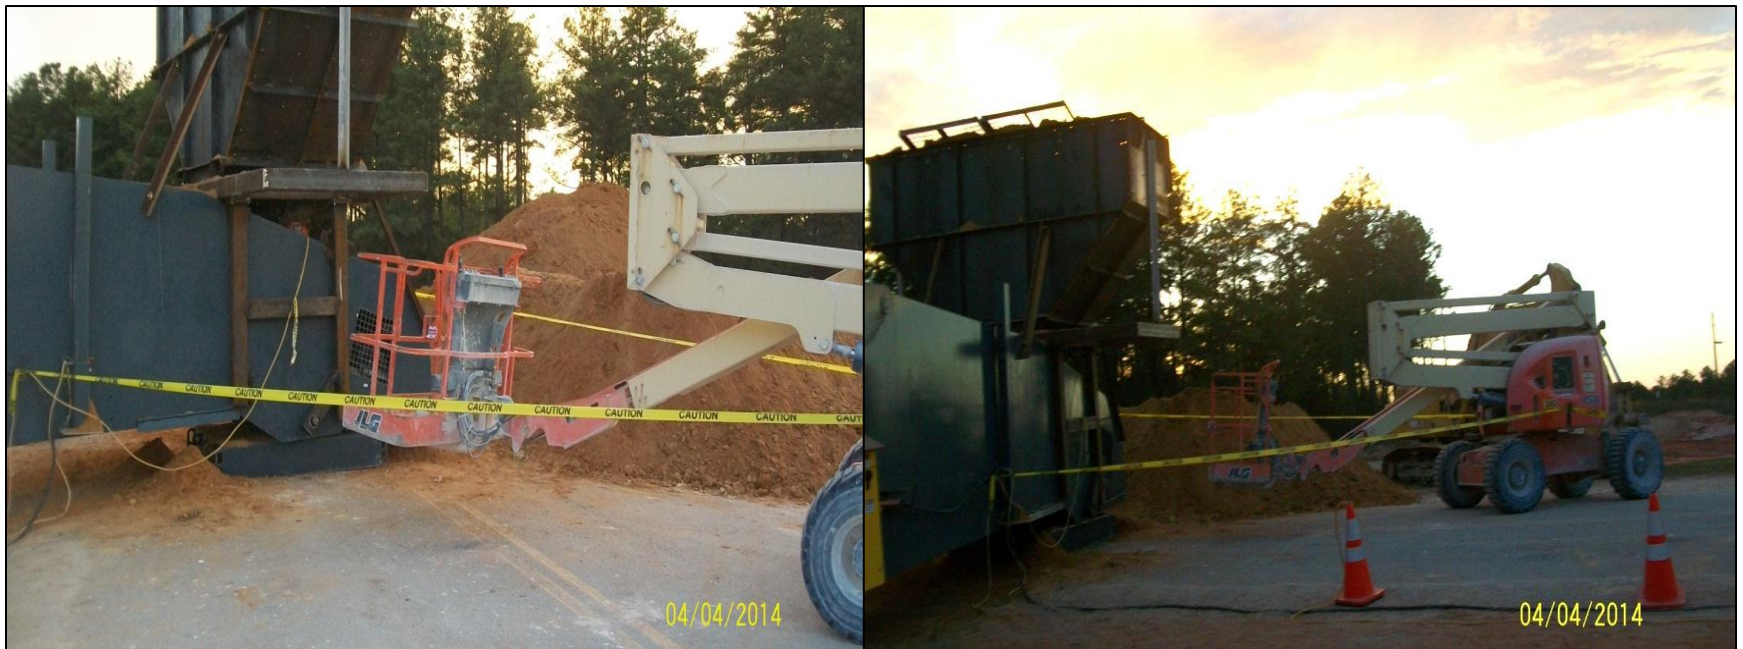
April 4, 2014

Common Clay Facility - A manlift operator working on a hopper from the basket was pinned between the controls of the manlift and steel tubing on the hopper. The basket was located on the opposite end of the manlift causing the tram levers to operate backwards. When the operator pushed the lever forward the man-lift moved backwards. The operator suffered fractured ribs, bruised back, and was hospitalized for two days.

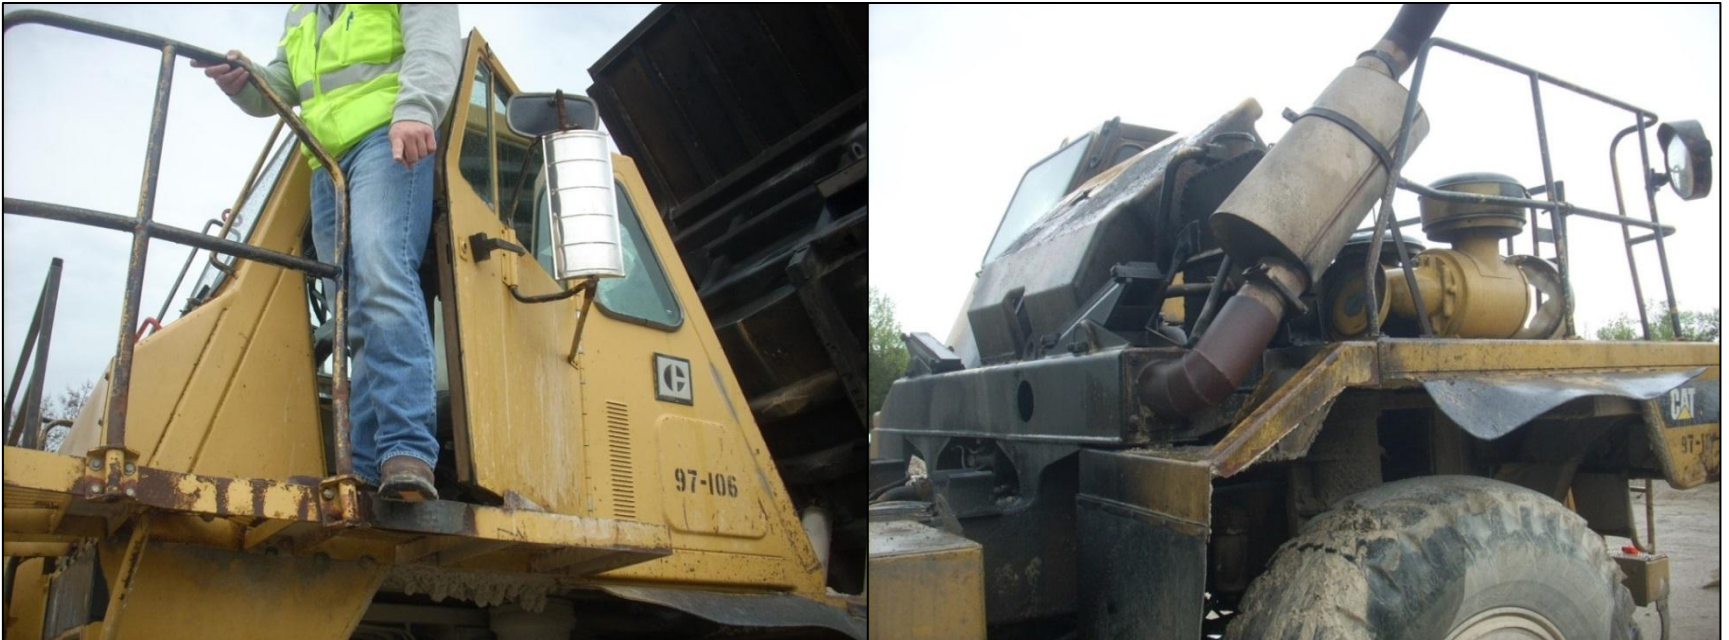
April 17, 2014

Surface Limestone Mine- Flames and smoke above the cab platform from a broken hydraulic hose prompted the operator to jump from the cab of a CAT 769C, 35 Ton Haul Truck. The cab was equipped with a fire extinguisher but the intensity of the flames caused him to jump. He fell seven feet, fracturing his right foot and left tibia at the knee and severely bruising his elbow.

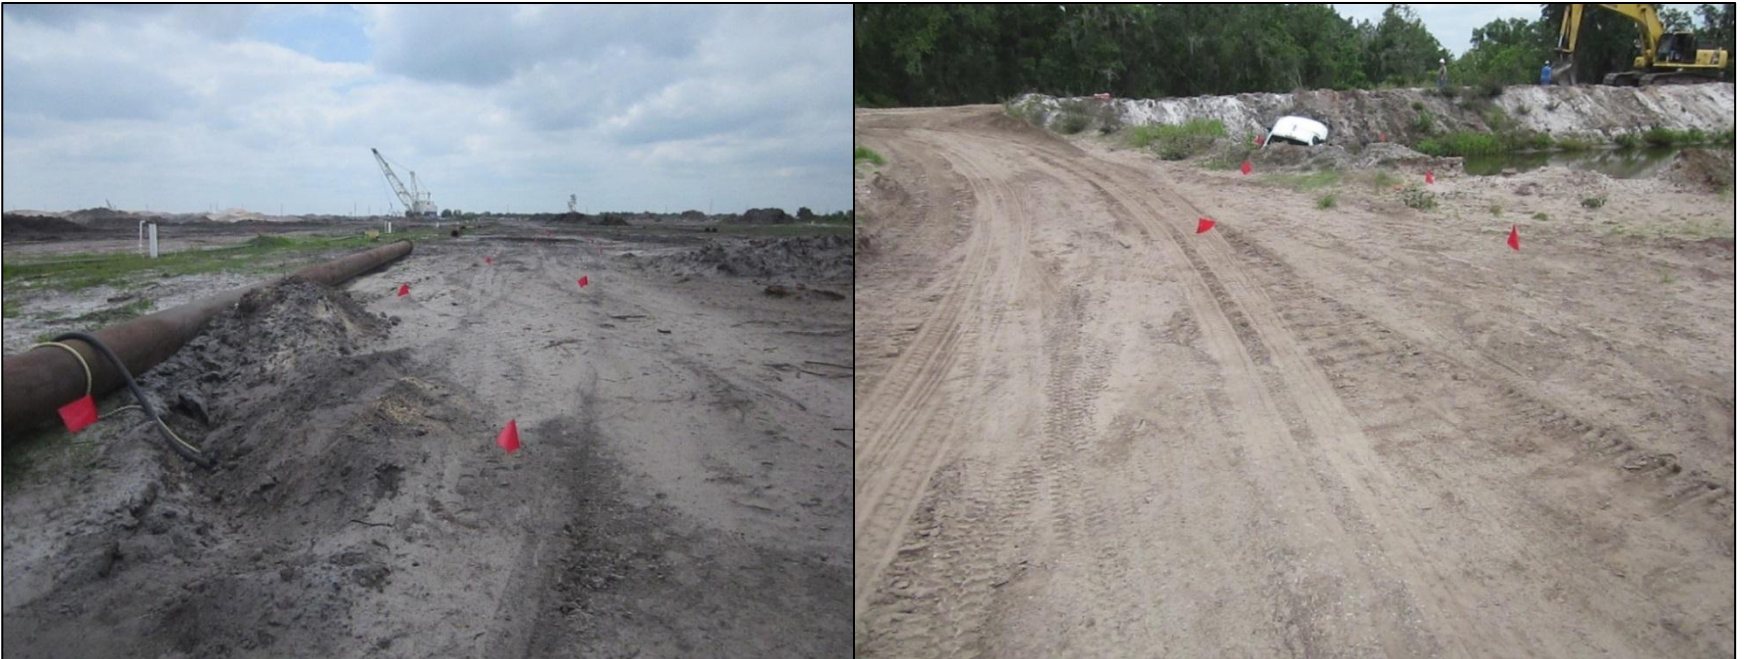
April 22, 2014

Surface Phosphate Mine - A passenger in a pickup truck was injured when the driver lost control of the truck due to excessive speed. The truck passed through a berm and landed on its side in a water-filled ditch. The injured employee suffered contusions to the chest.

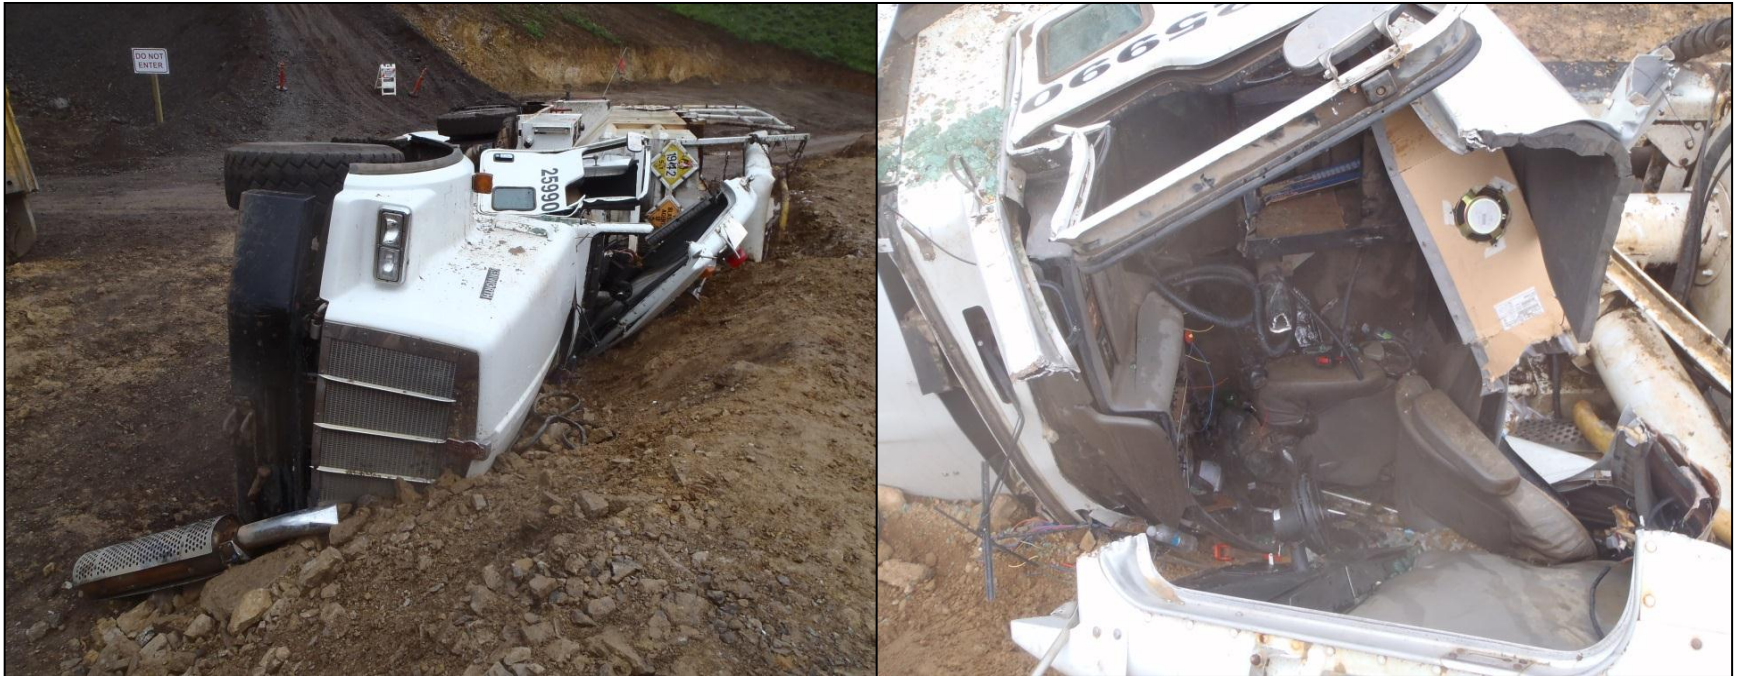
June 27, 2014

A miner operating a bulk explosives truck lost control of the truck, traveled down a steep slope and crashed into a berm. The miner was pinned inside the vehicle until rescue personnel could extract him.

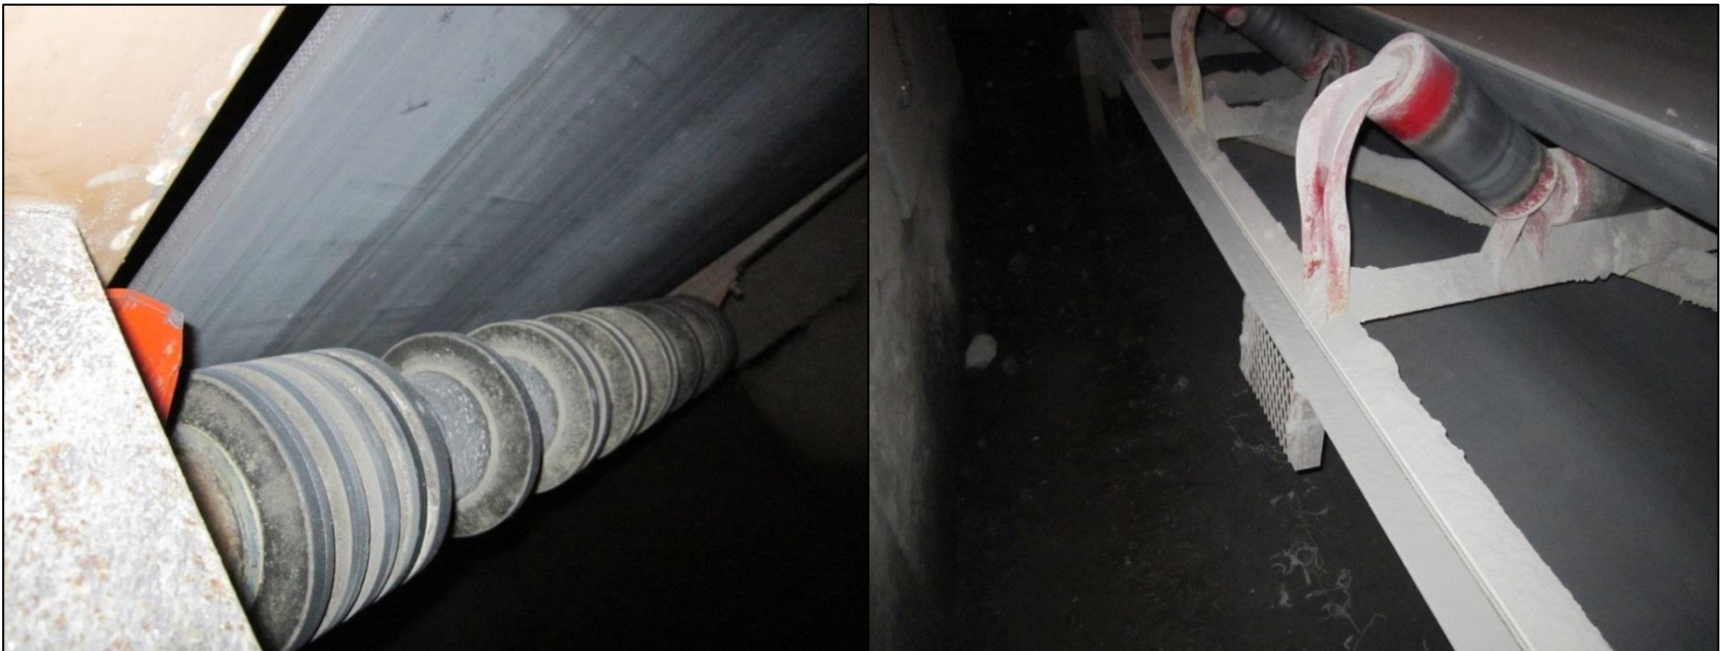
June 30, 2014

Surface Crushed and Broken Stone Mine – A miner attempted to remove a rock from a belt conveyor return roller while the conveyor was operating. The miner's arm was caught between the moving conveyor and the return roller, severely burning and lacerating the miner's arm. The conveyor should have been shut down and locked out.

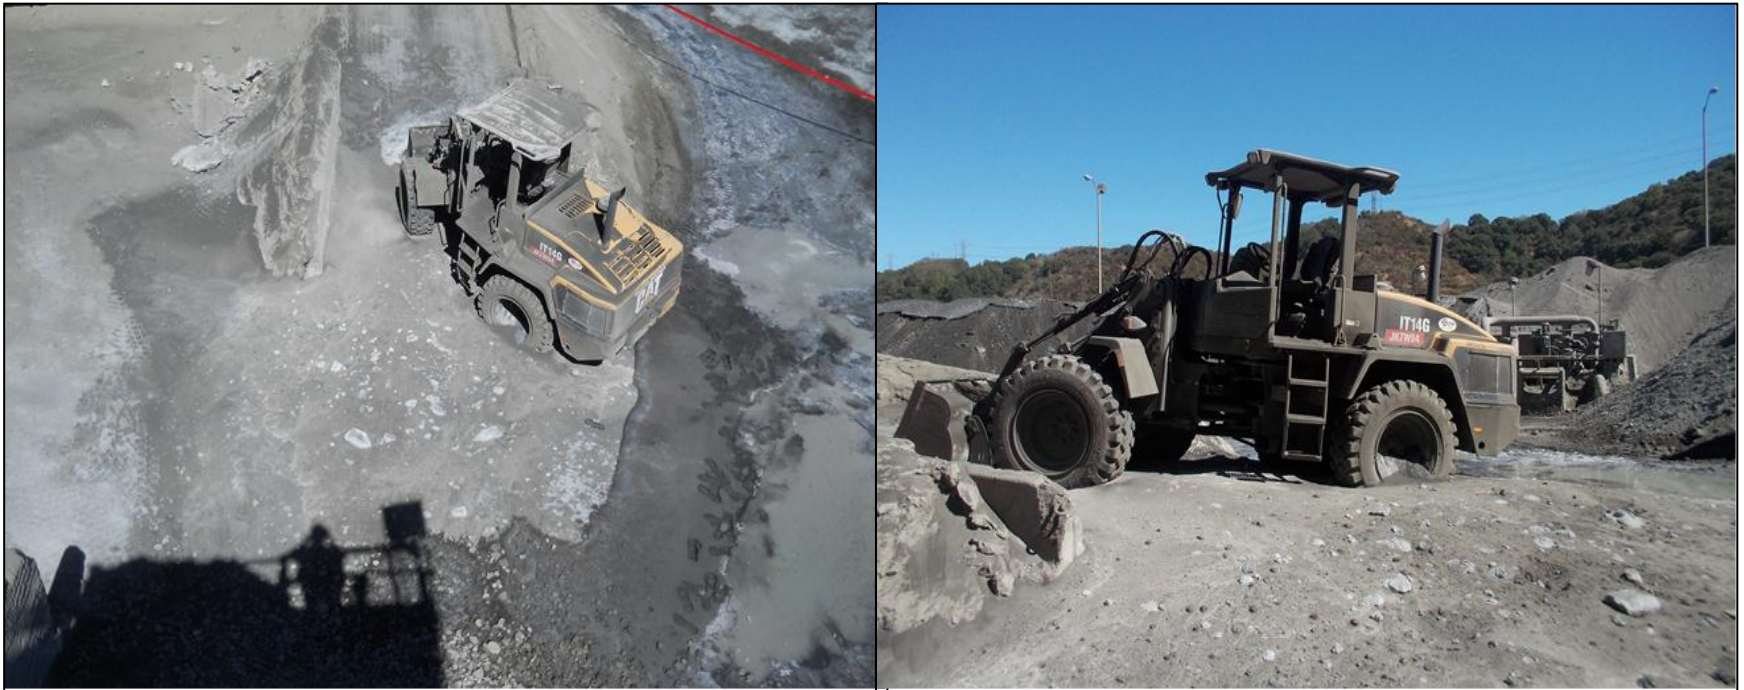
September 9, 2014

Cement Plant – A miner with 12 years working experience operating an open cab front end loader was seriously burned by hot cement clinker on his upper extremities (hands, forearms, knees, upper chest, neck, face, and eyes). He was not wearing proper appropriate personal protective equipment (PPE).

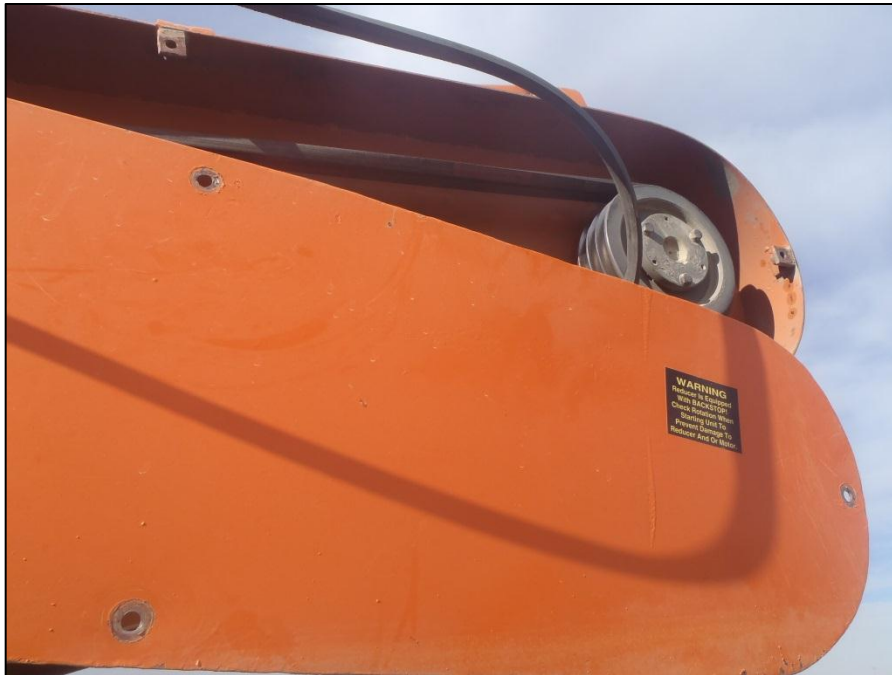
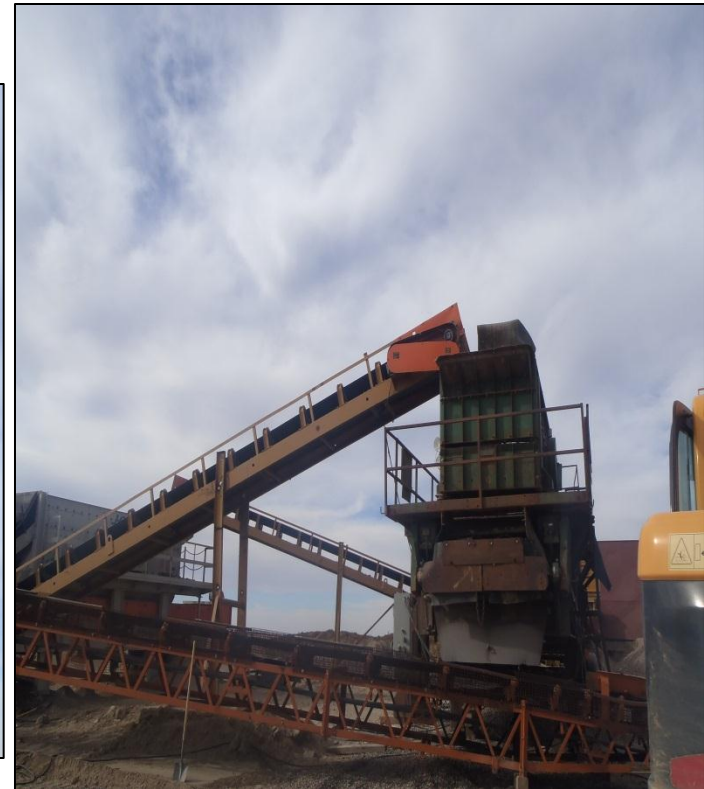
October 6, 2013

A plant foreman noticed that the guard for the V-belt drive on a conveyor belt had vibrated loose. The foreman shut the power off to the screen downstream but not to the conveyor drive, nor did he block the conveyor against hazardous motion. While attempting to reinstall the guard, the foreman's index and middle fingers became entangled between the V-belts and the pulley and were amputated.

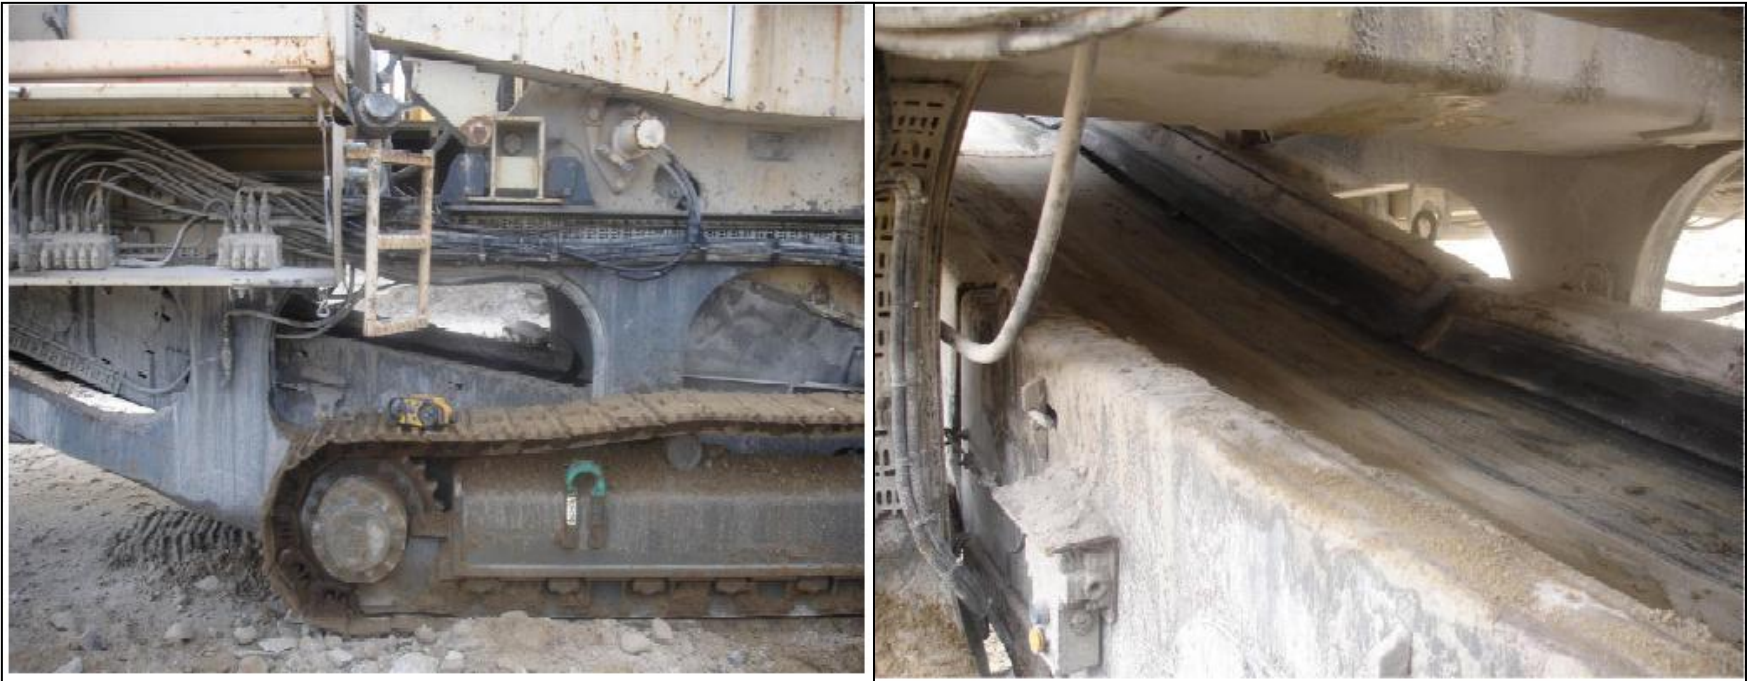
October 22, 2014

Surface Sand & Gravel mine - The crushing superintendent was leaning across a 42-inch belt conveyor while attempting to remove a portion of the rubber belt skirting. The belt conveyor was not locked out and was started remotely. The superintendent fell onto the belt and was pulled under the portable crusher 18 feet toward the discharge point. He managed to grab the cross belt magnet frame and hold on until the conveyor was stopped.

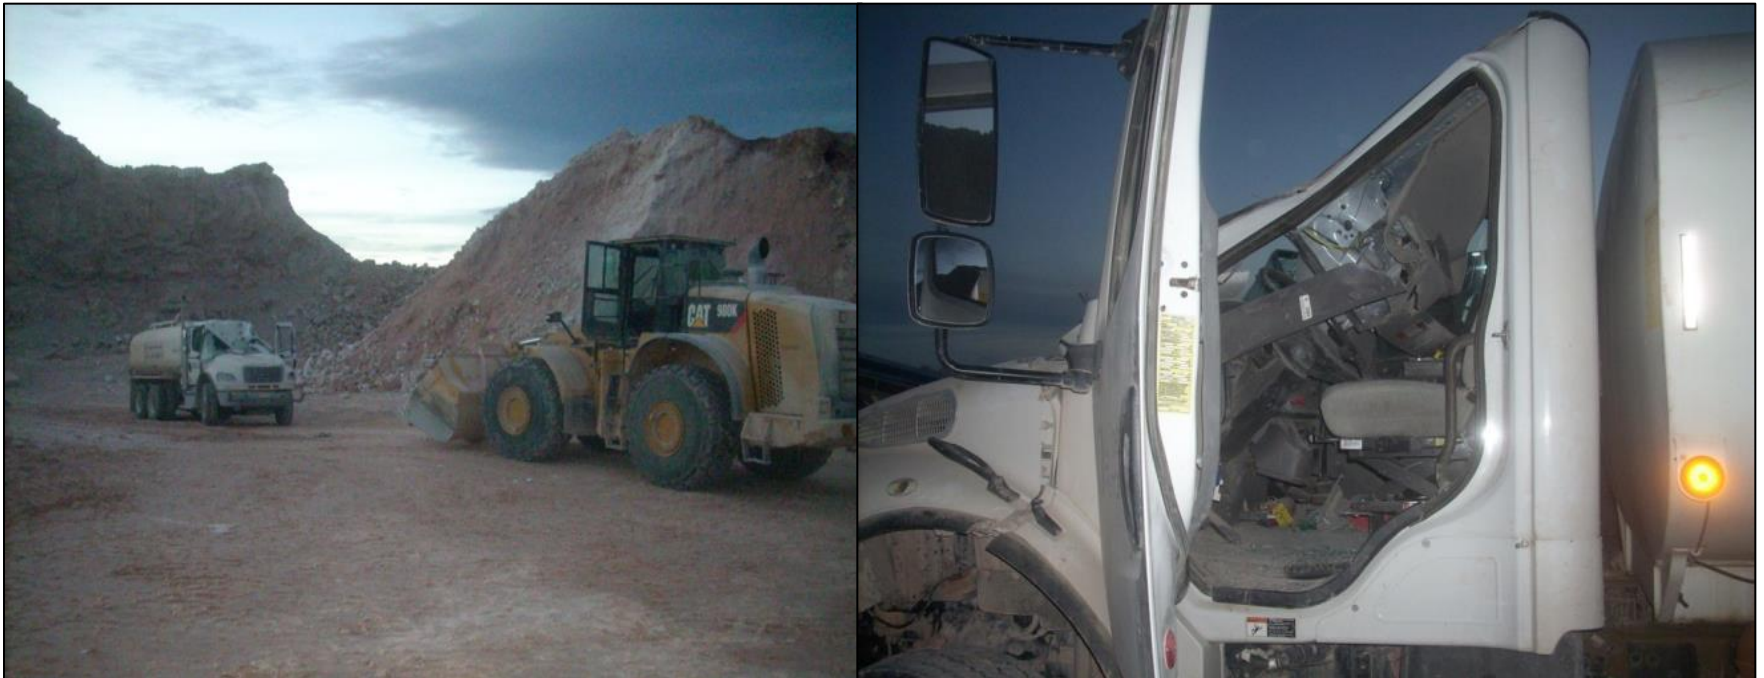
November 7, 2013

Surface Gypsum - A front-end loader traveling with a full bucket in the elevated position collided with a water truck in front of the rusher feed ramp. The rising sun temporarily blinded the loader operator, who did not see the water truck in his path. There was extensive damage to the truck's cab but no injury occurred .

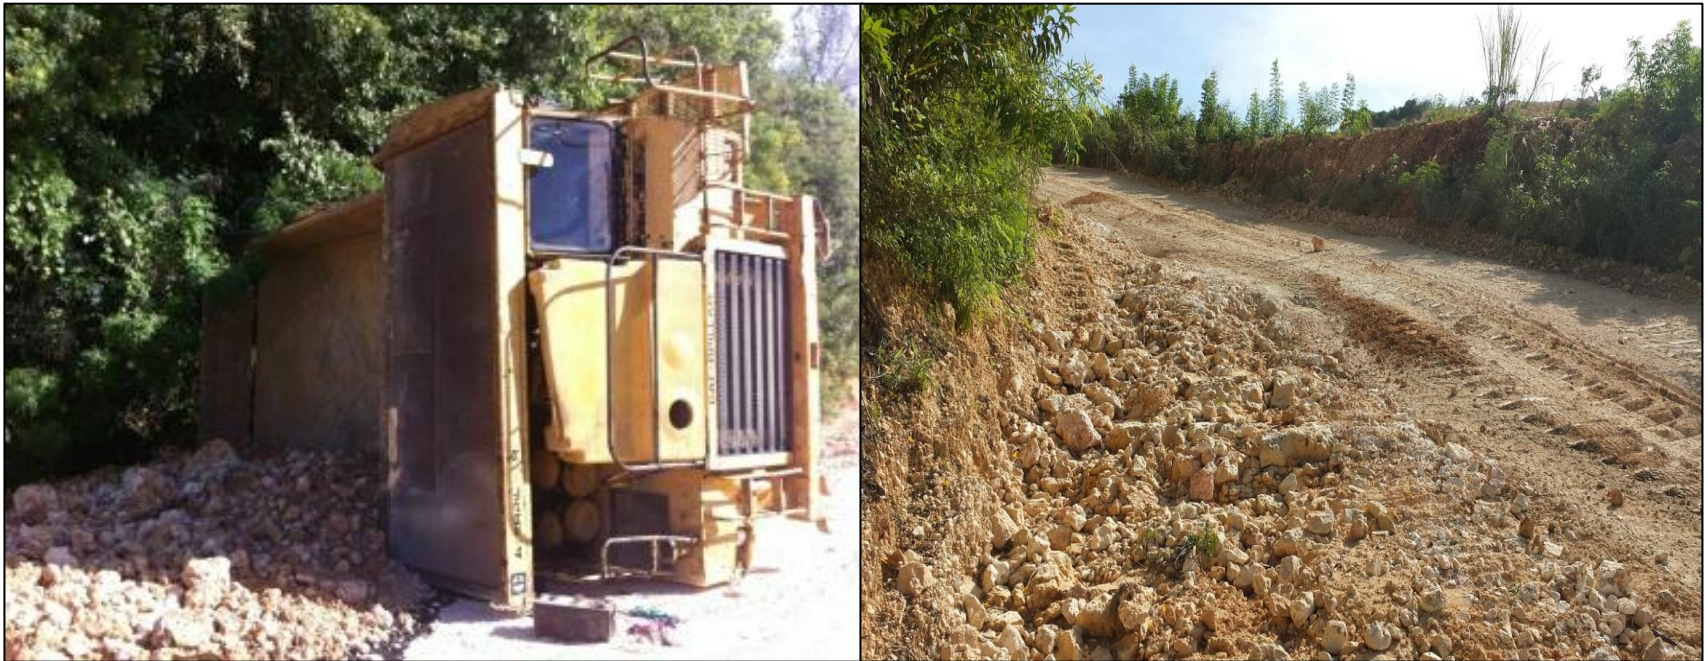
November 11, 2014

Crushed Broken Limestone Mine - Surface – A haul truck operator was ejected from his haul truck when he lost control and overturned as he was traveling up a steep haulage road. The miner suffered a punctured lung, abrasions, broken ribs, and fractured elbow. He was not wearing a seat belt.

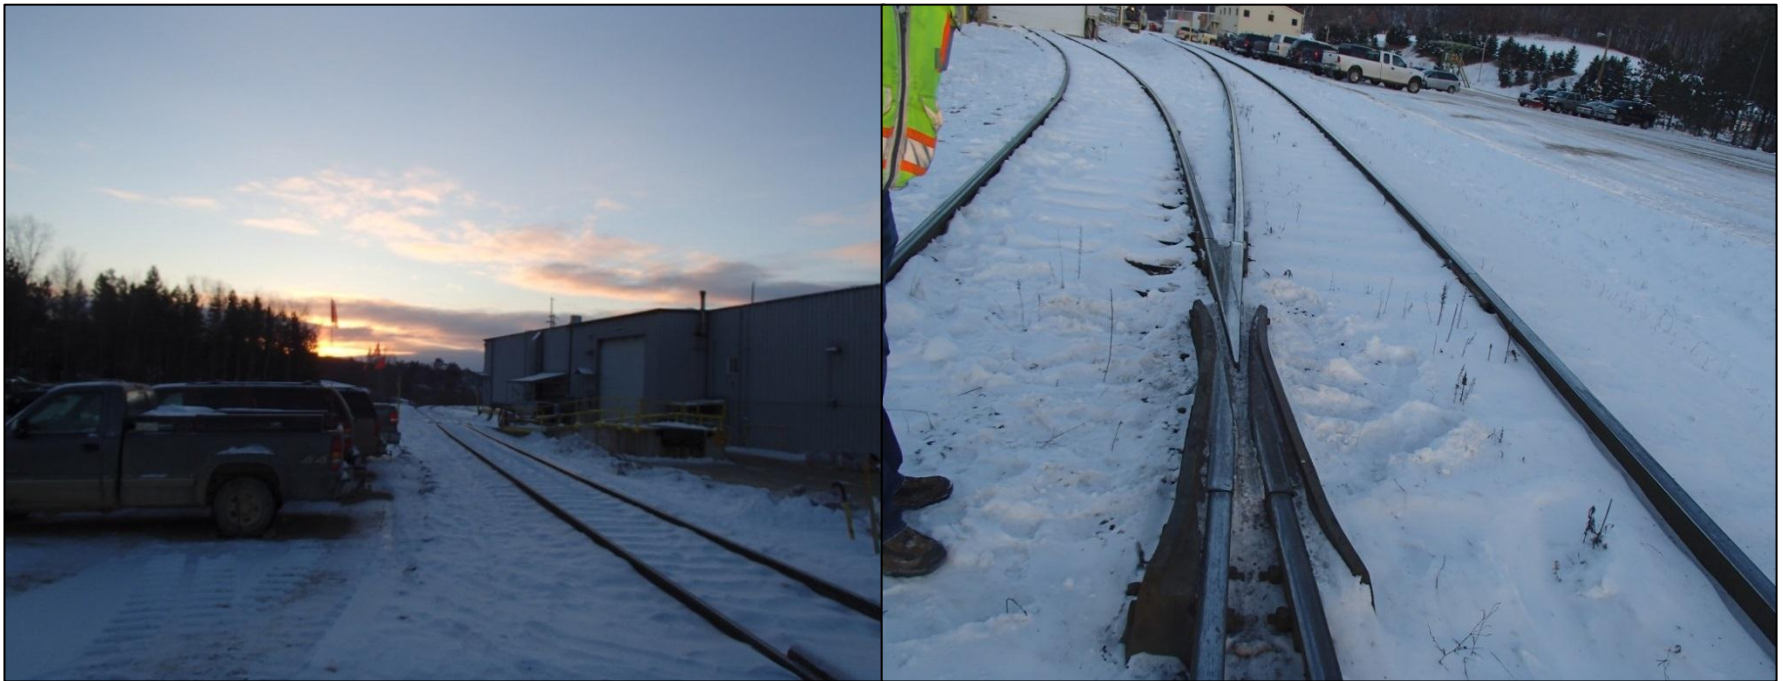
November 16, 2014

Industrial Sand mine – A miner was clearing snow off a rail switch with a leaf blower. The miner was wearing hearing protection and did not hear or see an approaching train. The miner was struck by the train, knocked to the ground, and suffered an amputated arm when a railcar ran over his arm.

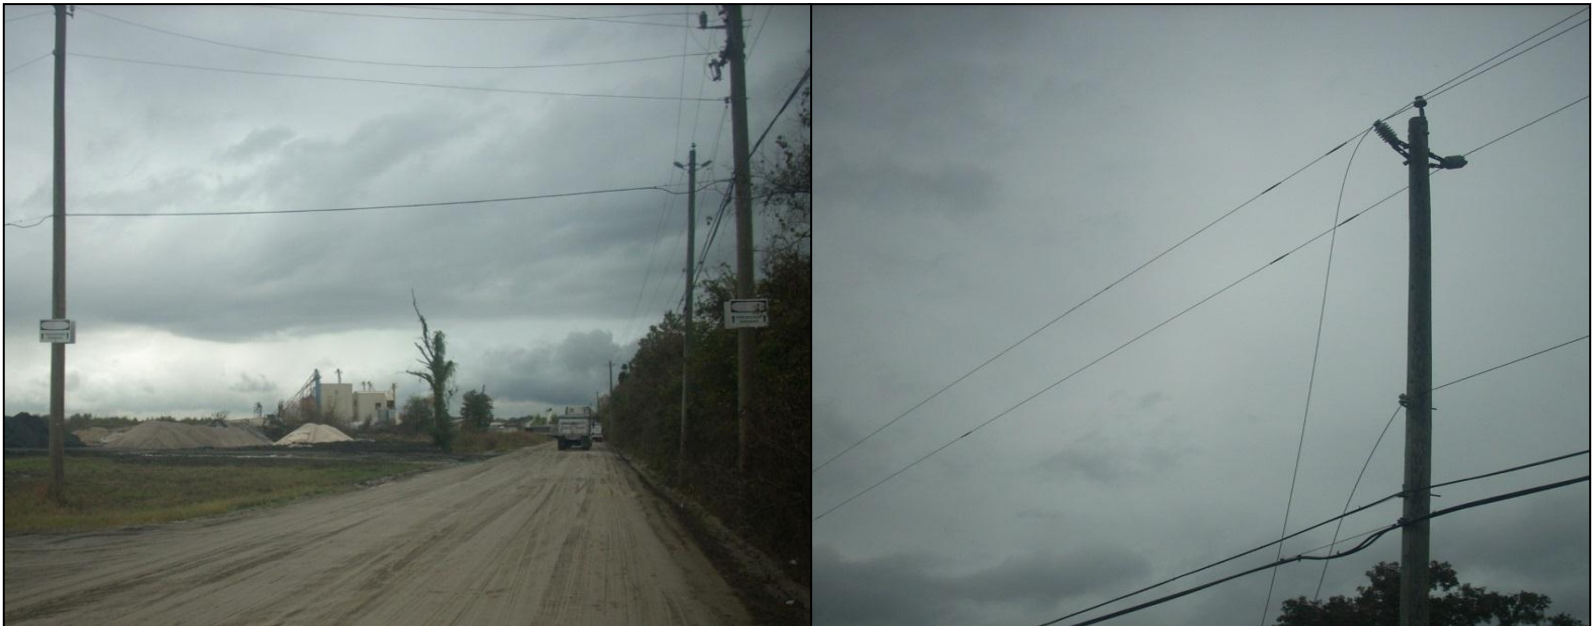
December 2014

Surface Sand mine – When a truck driver raised the bed of his truck to empty material, the truck bed contacted an overhead 7,200-volt power line. Other drivers in the area saw the driver start to get out of the truck and warned him to stay inside the cab. The power company de-energized the line and the truck was removed from the area. Had the driver exited his truck he could have been fatally electrocuted.

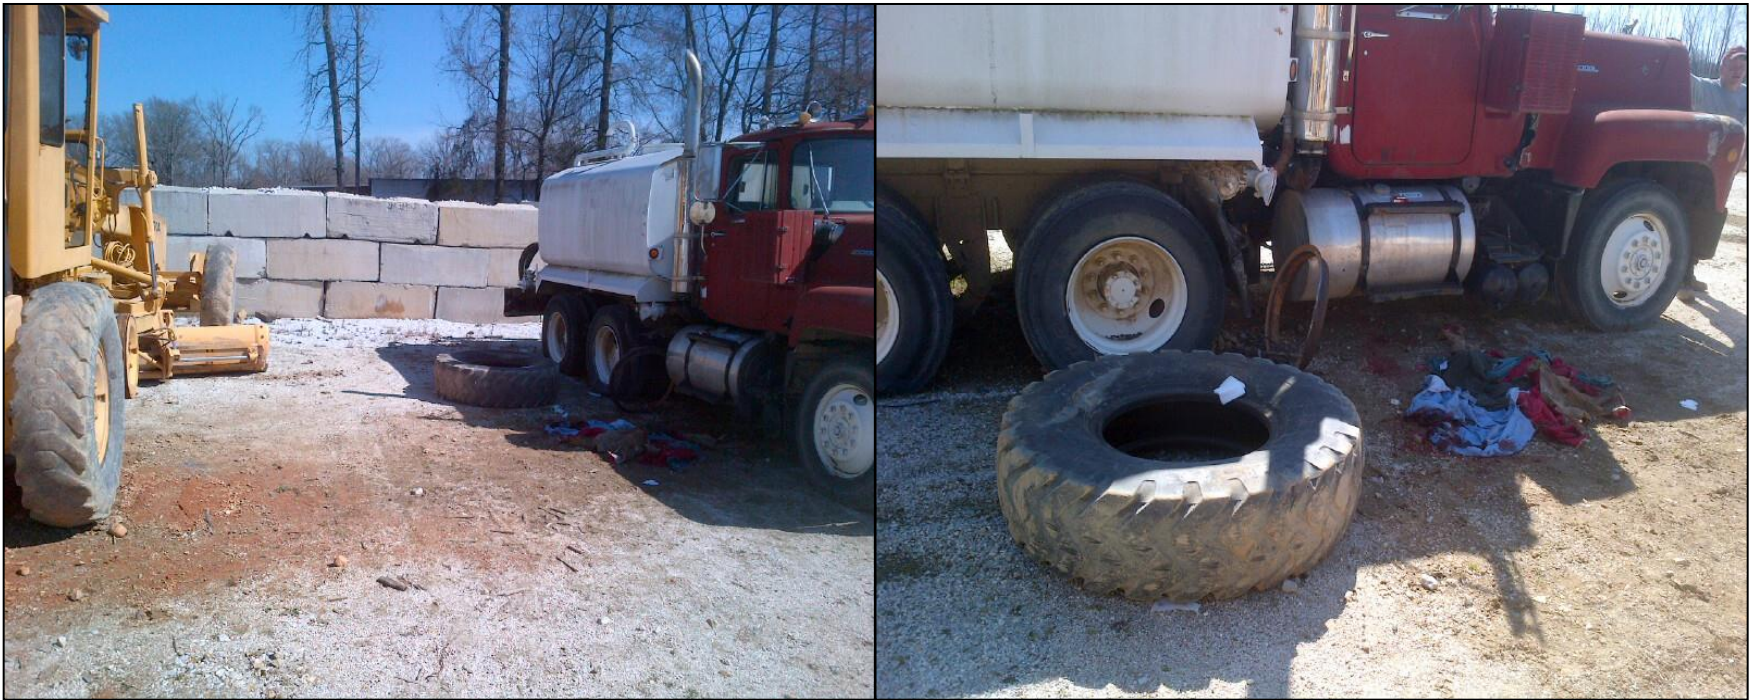
March 2014

Surface Construction Sand & Gravel mine – A flat tire on the Grader was being inflated and had approximately 30 psi when it blew off the wheel rim. The victim had just checked the tire and was standing approximately 3 feet in front of it when the metal rim exploded, blowing him against a water truck 15 feet away.

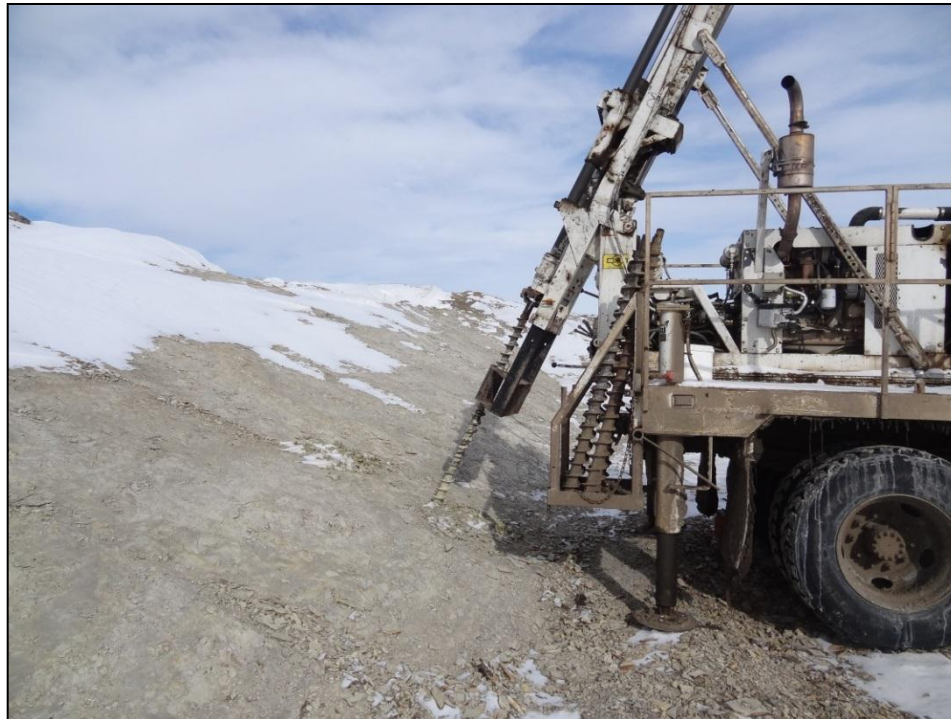
February 26, 2014

Two miners were drilling holes with a truck mounted drill. The drill operator was at the controls of the drill as the assistant approached the rotating auger and reached down to collect a sample of drill cuttings. The drill assistant's vest was entangled in the drill steel and he was pulled into the rotating drill steel. The drill operator stopped the rotation before the assistant was seriously injured.

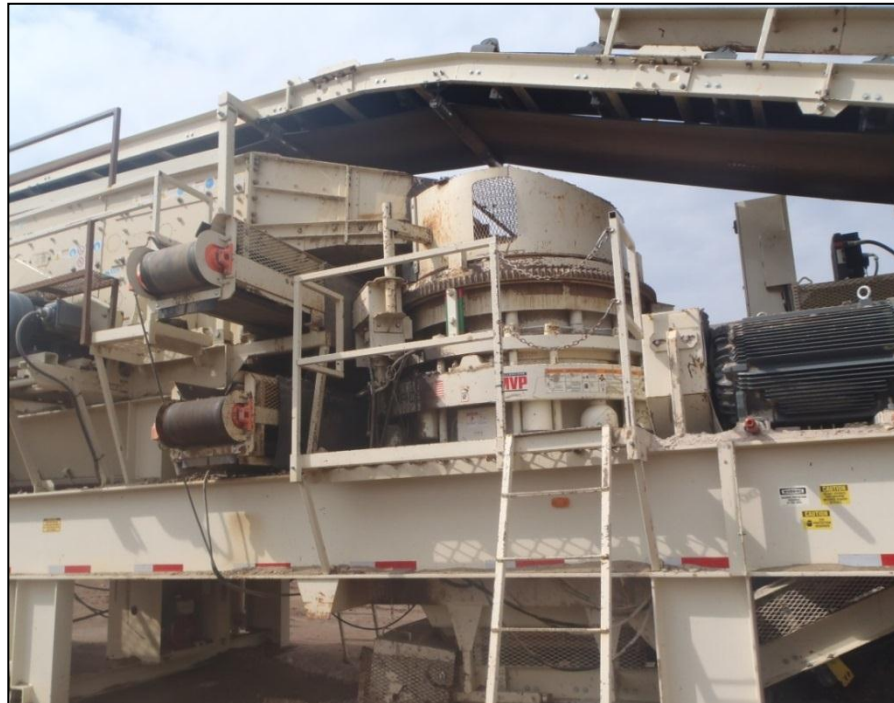
April 22, 2014

Surface Sand & Gravel Mine - A miner was standing on the side of the cone crusher cleaning material from the cone supply chute from the screen deck. When a wind gust blew his hard hat off and caused the miner to shift positions, the paddle bar he was using contacted the vibrating screen. The opposite end struck the miner in the jaw and knocked him over the handrail to the ground.

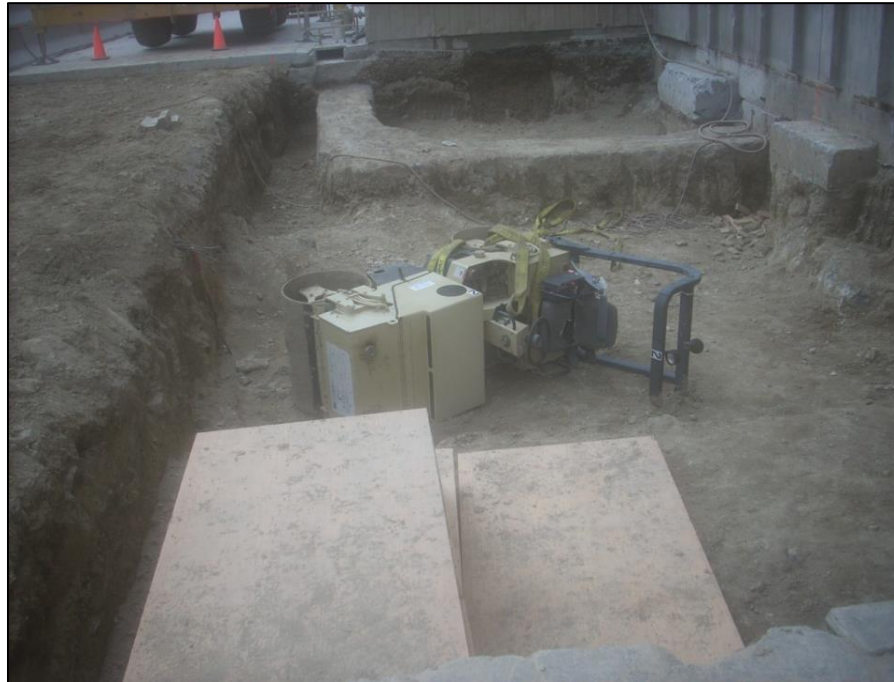
May 14, 2014

Cement Facility - A roller compactor operator was seriously injured while compacting gravel around the unbermed and open excavation. As the machine tipped into the excavation, the miner unbuckled his seatbelt and tried to jump clear, but the compactor landed on top of him, crushing his hip. Had the equipment operator stayed in place with his seatbelt secured, his injuries likely would have been minor. This accident likely would not have occurred had berms been in place.
